**DEPARTMENT OF TRANSPORTATION**

Contract #: 04-0120F4Cty: SF/ALA Rte: 80 PM: 13.2/13.9File #: 69.28**WELDING INSPECTION REPORT****Resident Engineer:**Siegenthaler, Peter**Address:** 333 Burma Road**City:** Oakland, CA 94607**Report No:** WIR-021535**Date Inspected:** 05-Mar-2011**Project Name:** SAS Superstructure**OSM Arrival Time:** 700**Prime Contractor:** American Bridge/Fluor Enterprises, a JV**OSM Departure Time:** 1900**Contractor:** Zhenhua Port Machinery Company, Ltd (ZPMC), Changxing Island **Location:** Shanghai,China**CWI Name:** Lv Li Qing /Geng Wei**CWI Present:** Yes No**Inspected CWI report:** Yes No N/A**Rod Oven in Use:** Yes No N/A**Electrode to specification:** Yes No N/A**Weld Procedures Followed:** Yes No N/A**Qualified Welders:** Yes No N/A**Verified Joint Fit-up:** Yes No N/A**Approved Drawings:** Yes No N/A**Approved WPS:** Yes No N/A**Delayed / Cancelled:** Yes No N/A**Bridge No:** 34-0006**Component:** OBG**Summary of Items Observed:**

## WELDING INSPECTION REPORT

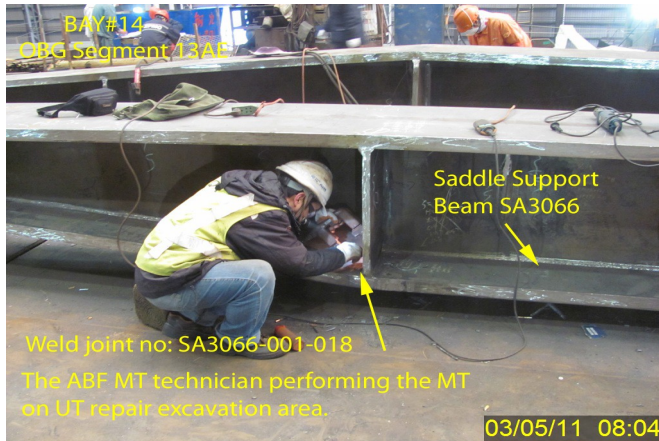
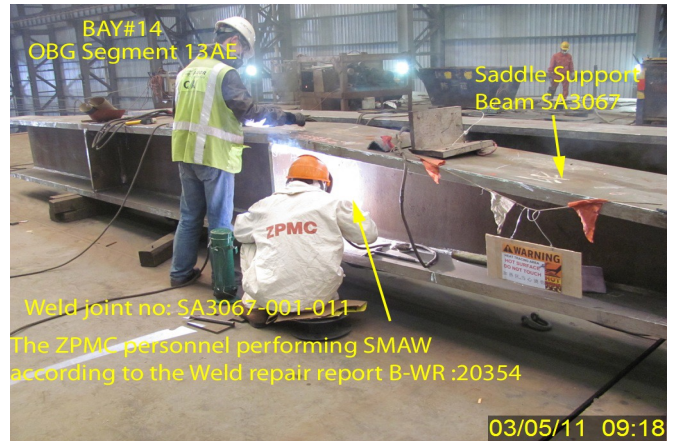
Unless otherwise noted, all work observed on this date appeared to generally comply with applicable contract documents.
